Monitoring Cruise
at the Boston Lighthouse Disposal Site,
August 1994

Disposal Area Monitoring System DAMOS

Contribution 113
August 1996

Report No.
SAIC No. 328

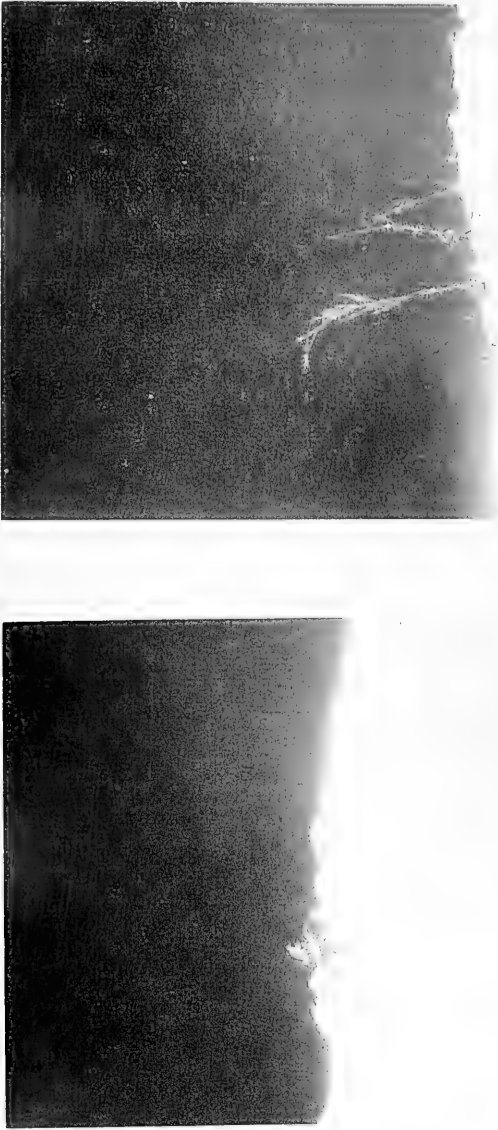
Figure 3-2. Light gray, high reflectance Boston Blue Clay located at Stations C3-10 (A) and C2-7 (B). Note the large pellet-filled burrow (A) and the actively feeding Stage III polychaete (B).

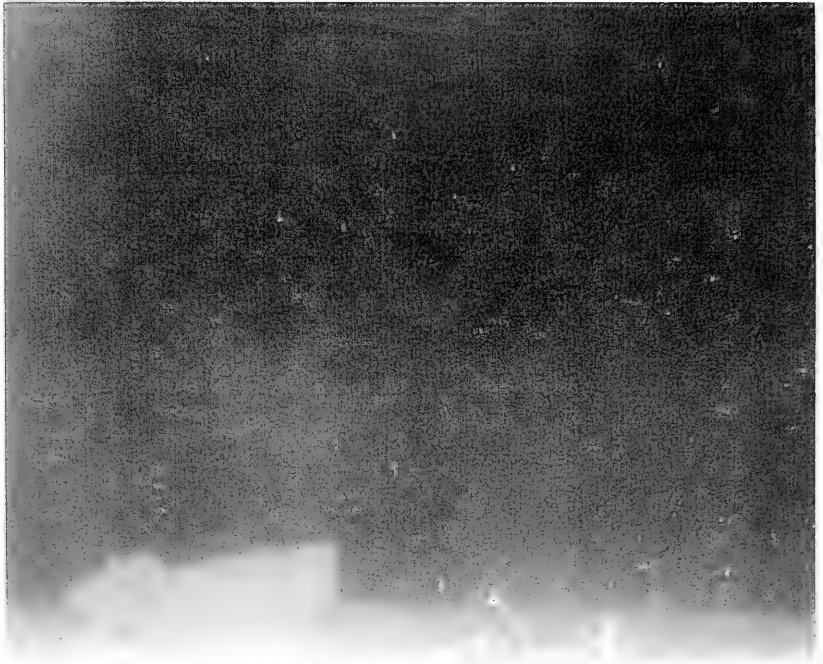
Figure 3-3. Layer of biogenically reworked sediments over dredged material and large Stage III polychaete feeding in the dredged material layer
